Highway Department Survey Evidence

A13

History of Surveys

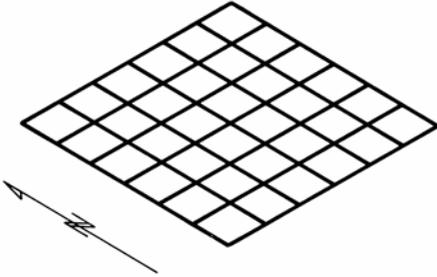
1868-69

1868 C.C. Tracy surveyed the exterior boundaries and subdivisional lines of T. 34 N., R. 55 E., in 1868 and 1869.

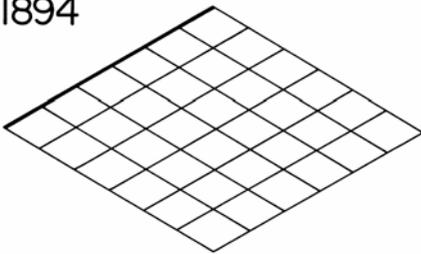
1894 H.S. Maxson resurveyed the north boundary.

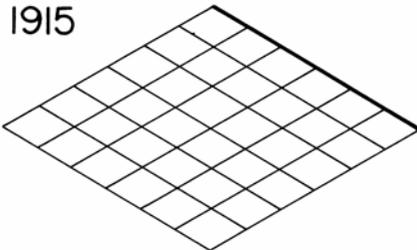
1915 Winfred A. Pray resurveyed the east boundary. Pray recovered the corner of sections 7, 12, 13 and 18 and restored the remaining corners by single proportionate measurement.

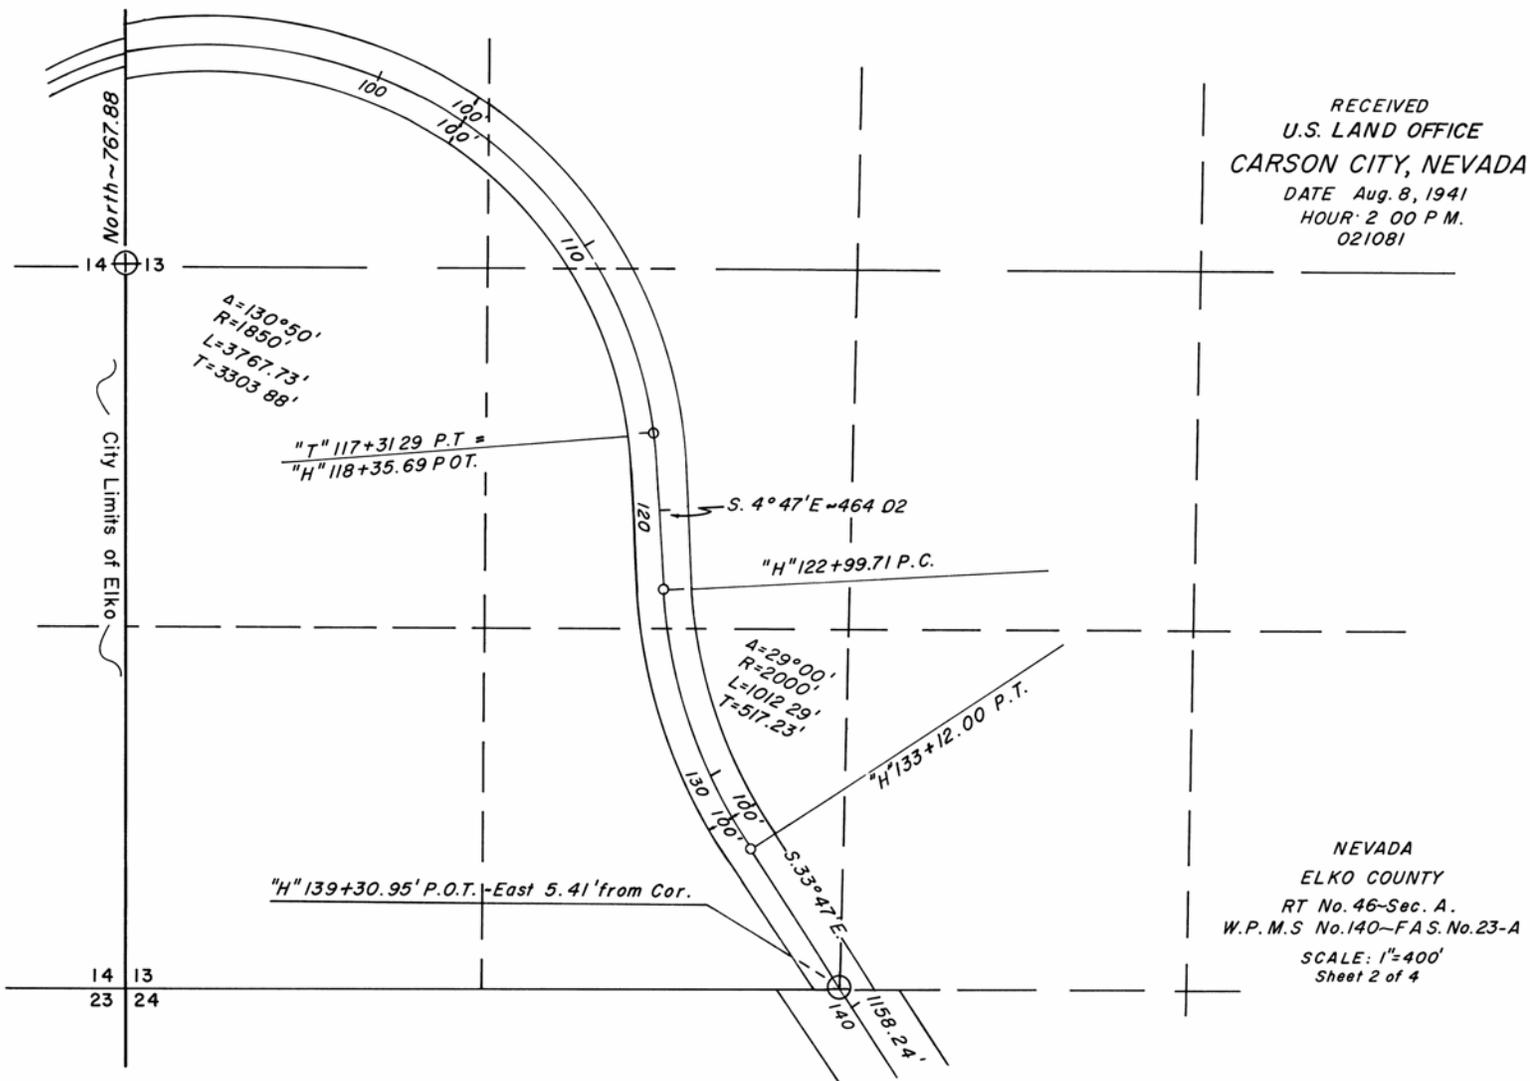
Figure 1 - Portion of Highway Dept. Map

In 1941, a Nevada State Highway Department map which showed 6 miles of Route No. 46 was filed in the land Office of the G.L.O., then located in Carson City. The map, which consisted of four sheets, showed the location of the highway across vacant public lands. Portions of sheets 2 and 3 are shown in figures 1 and 2.

As shown in figures 1 and 2, the $\frac{1}{4}$ section corner of sections 13 and 24 had been recovered by the Highway Department in 1941. The corner was tied in as being 5.41 feet west of highway centerline station "H" 139 + 30.95, a point on a tangent between curves. Figure 2 indicates that right-of-way markers were set left and right of this centerline station, marking a right-of-way which extends 200 feet each side of the centerline, measured 90° to the centerline, which bears S. $33^\circ 47' E$.

It must be determined whether or not the centerline station can be definitely established and, if so, the corner point must be determined from that. The wording on sheet 3 of 4 (figure 2) is not clear as to whether the corner was east or west of the highway centerline.

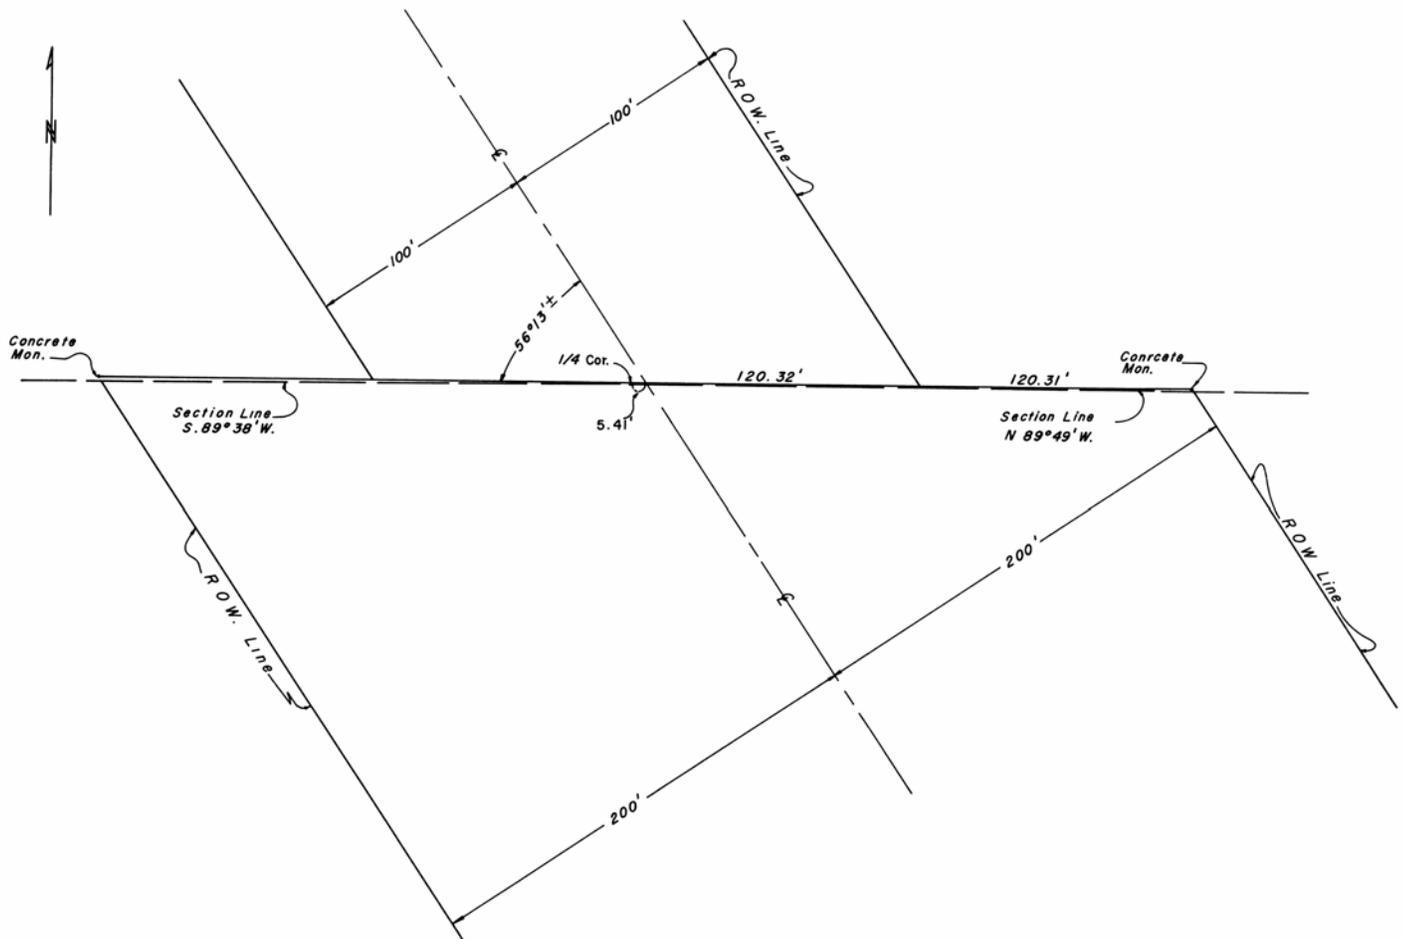
Figure 3 - Solution

Both right-of-way markers near the 1/4 section corner to sections 13 and 24 were monumented with 4x4 inch concrete posts and were readily recovered. The centerline station "H" 139 + 30.95 was restored at midpoint on line between the markers and the 1/4 section corner was set at a point 5.41 from the centerline. The measurement to the corner was made on a west bearing as determined by using the highway centerline as S. 33° 47' E. according to the Highway Department's reported value.

The corner was remonumented with a patented, copper-coated steel stake and brass cap. Two brass-capped iron posts were set for reference monuments, one N. 70° W. and the other S. 20° W., each 55 feet distant from the corner.

The section line was then resurveyed using the restored 1/4 section corner. This resulted in a bearing of N. 89° 49' W., 39.50 chains for the east 1/2 mile. The west half mile was S. 89° 38' W., 40.34 chains. These bearings and distances are fully compatible with the other section lines, and the original record of N. 89° 56' W., 80.08 chains for the mile. No gross distortion exists. Figure 3 is an enlargement of the situation at the 1/4 section corner. Neither highway right-of-way marker is located on the true section line, as dependently resurveyed.

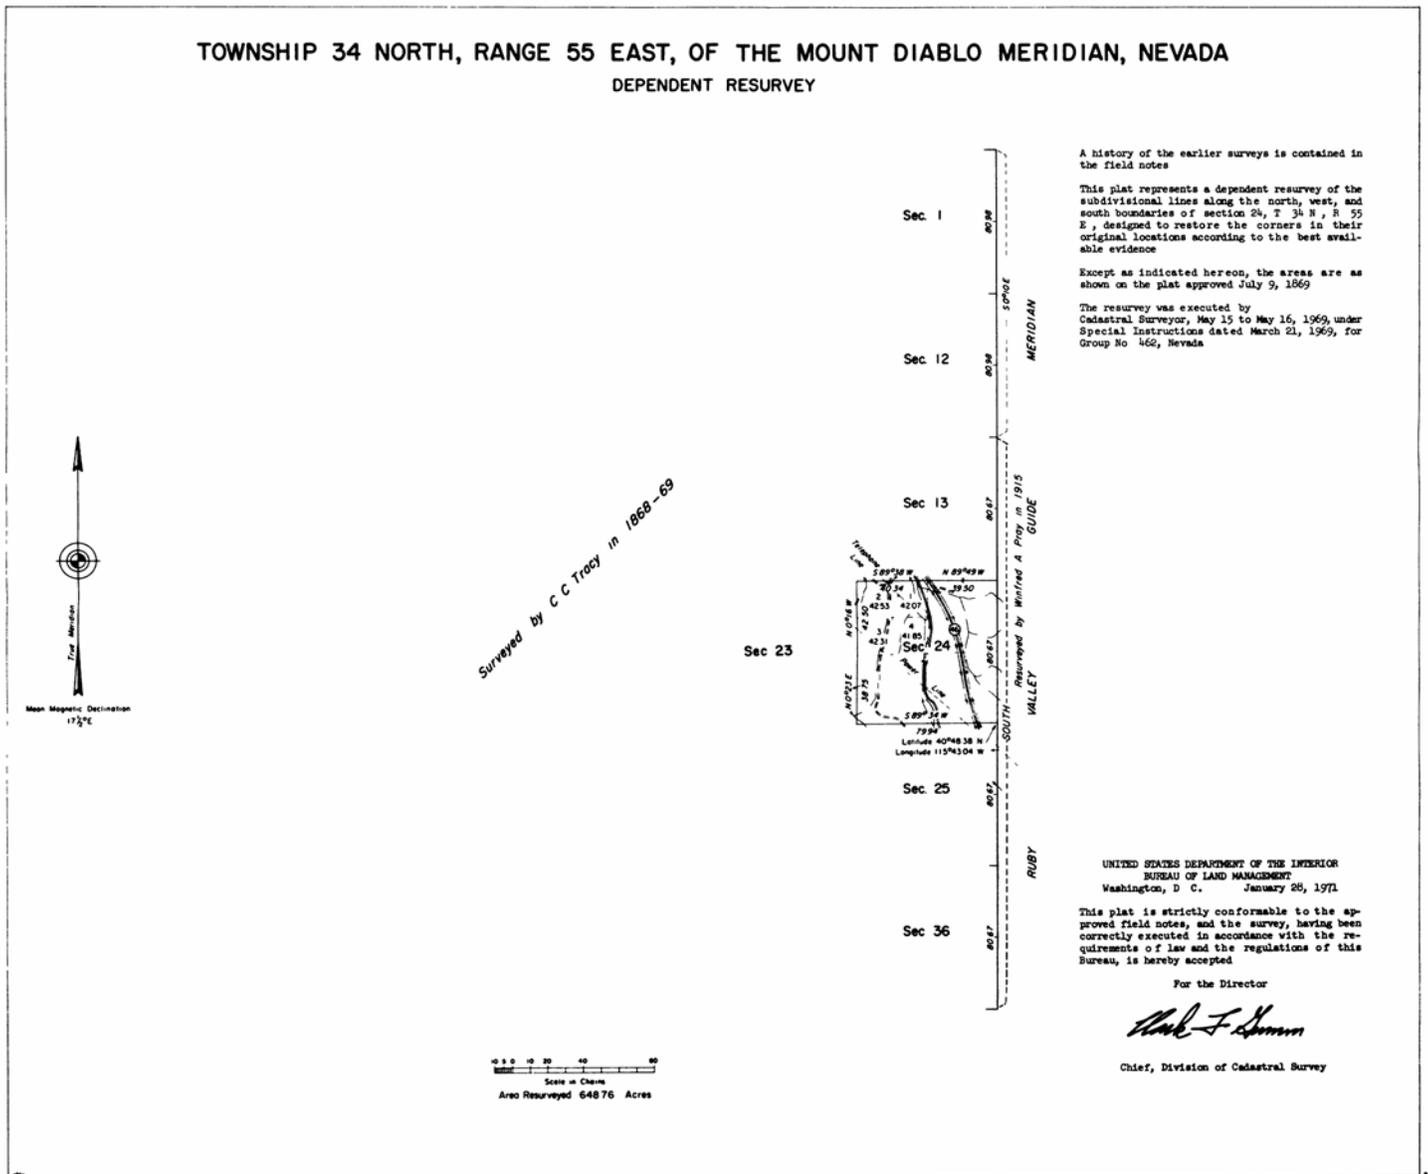
Figure 4 - Accepted Plat

Figure 4 is a copy of the dependent resurvey plat of section 24 which was accepted January 28, 1971.
